PROPERTY CONDITION ASSESSMENT
OF
WORLD TRADE CENTER PORTFOLIO

ONE WORLD TRADE CENTER

Merritt & Harris, Inc. Project Number 20-251E

December 6, 2000

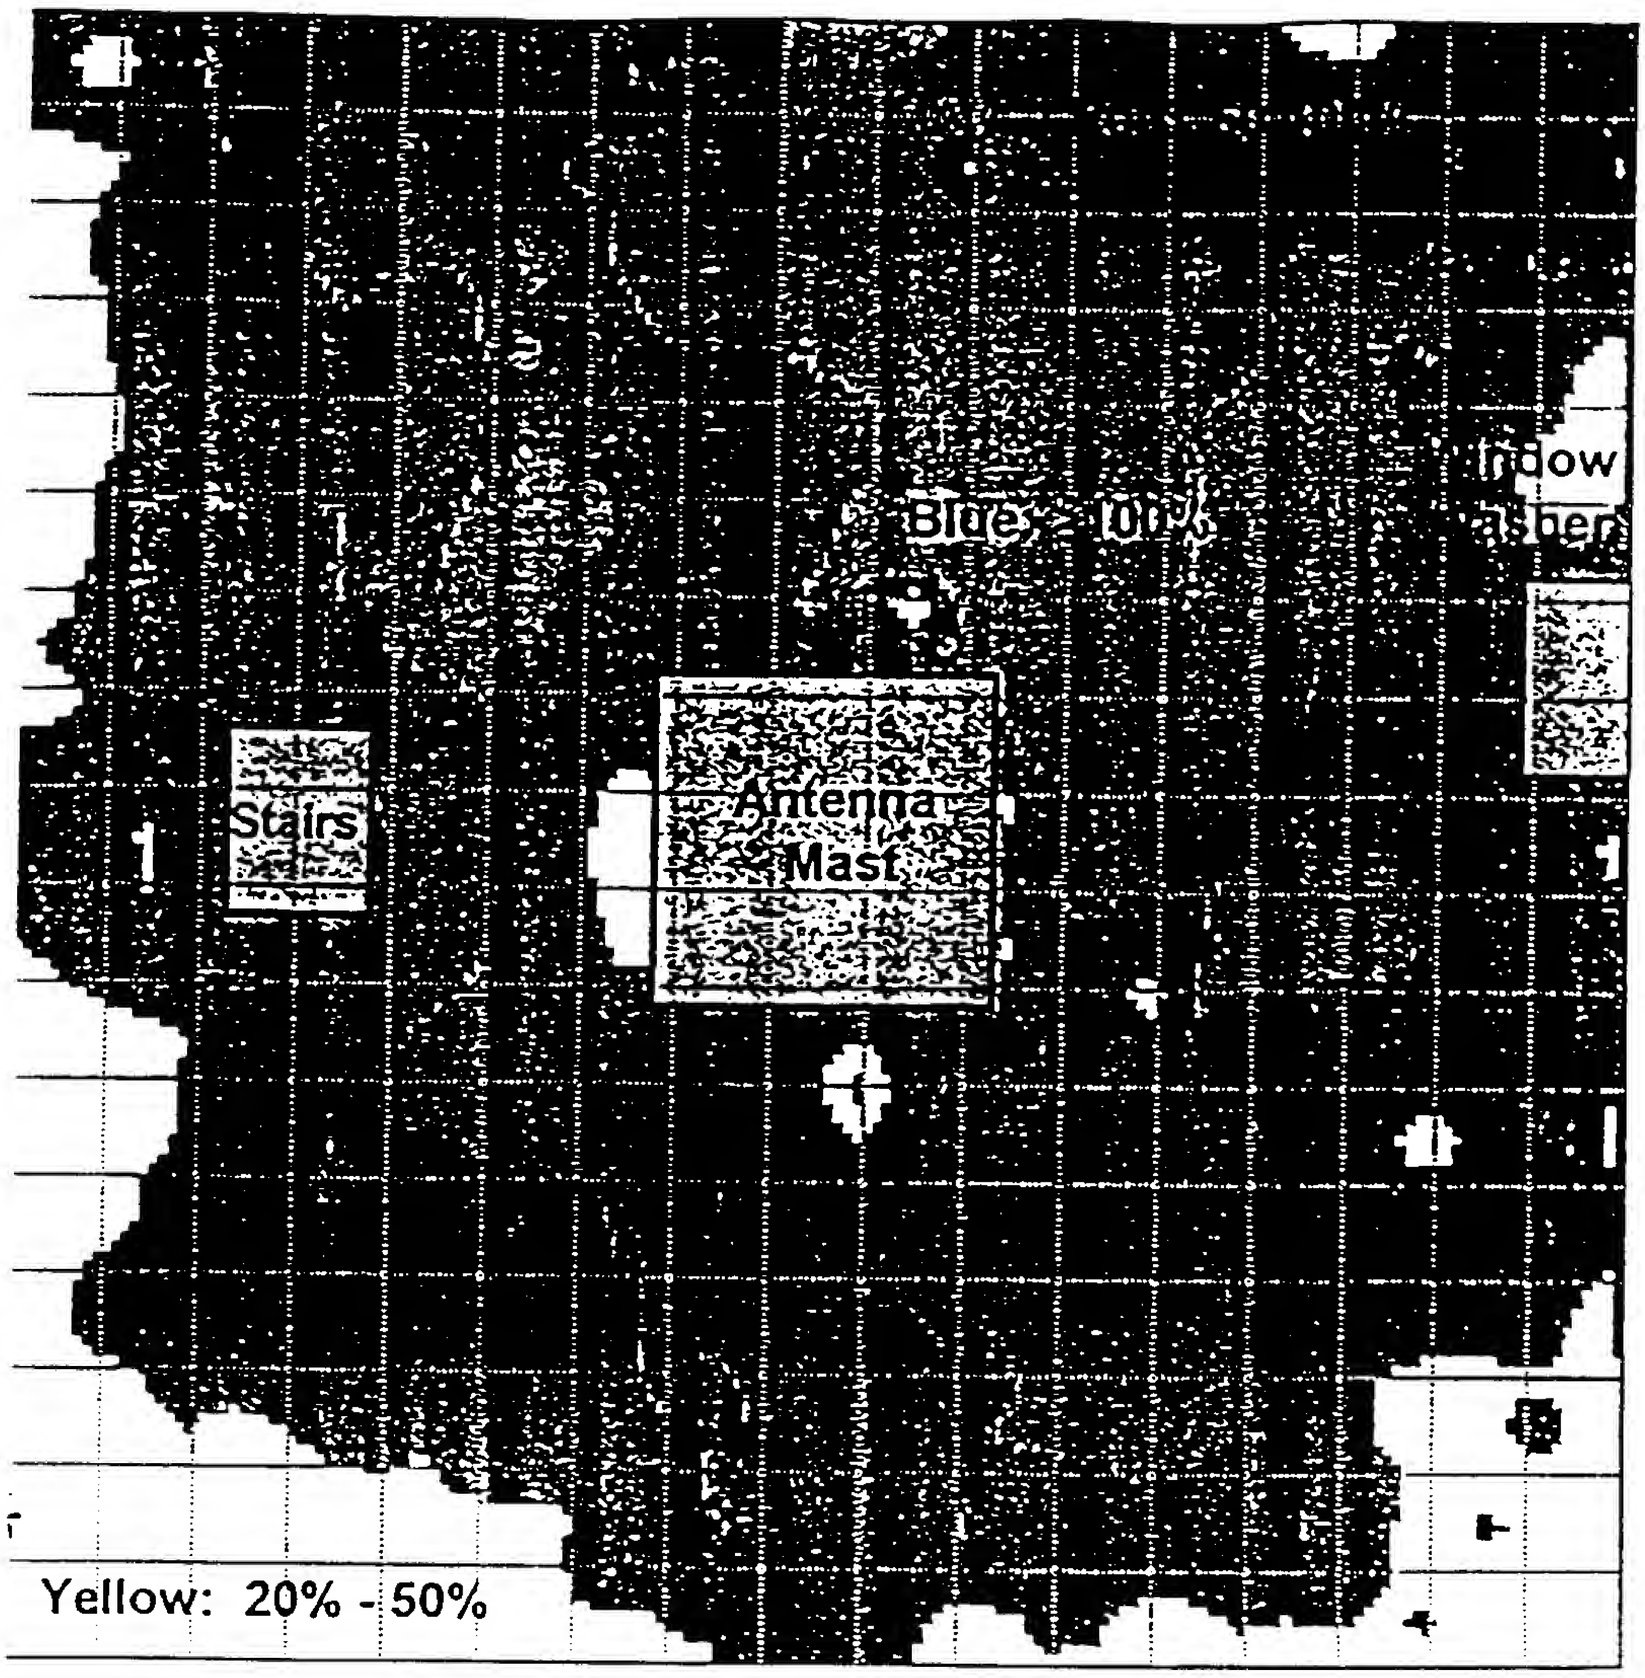
Figure 16. Roof map showing measured ambient RF fields on roof of north tower of World Trade Center during emergency backup broadcast operations with calculated maximum contributions from all wireless telecommunications antennas Maximum field is 373 0% MPE

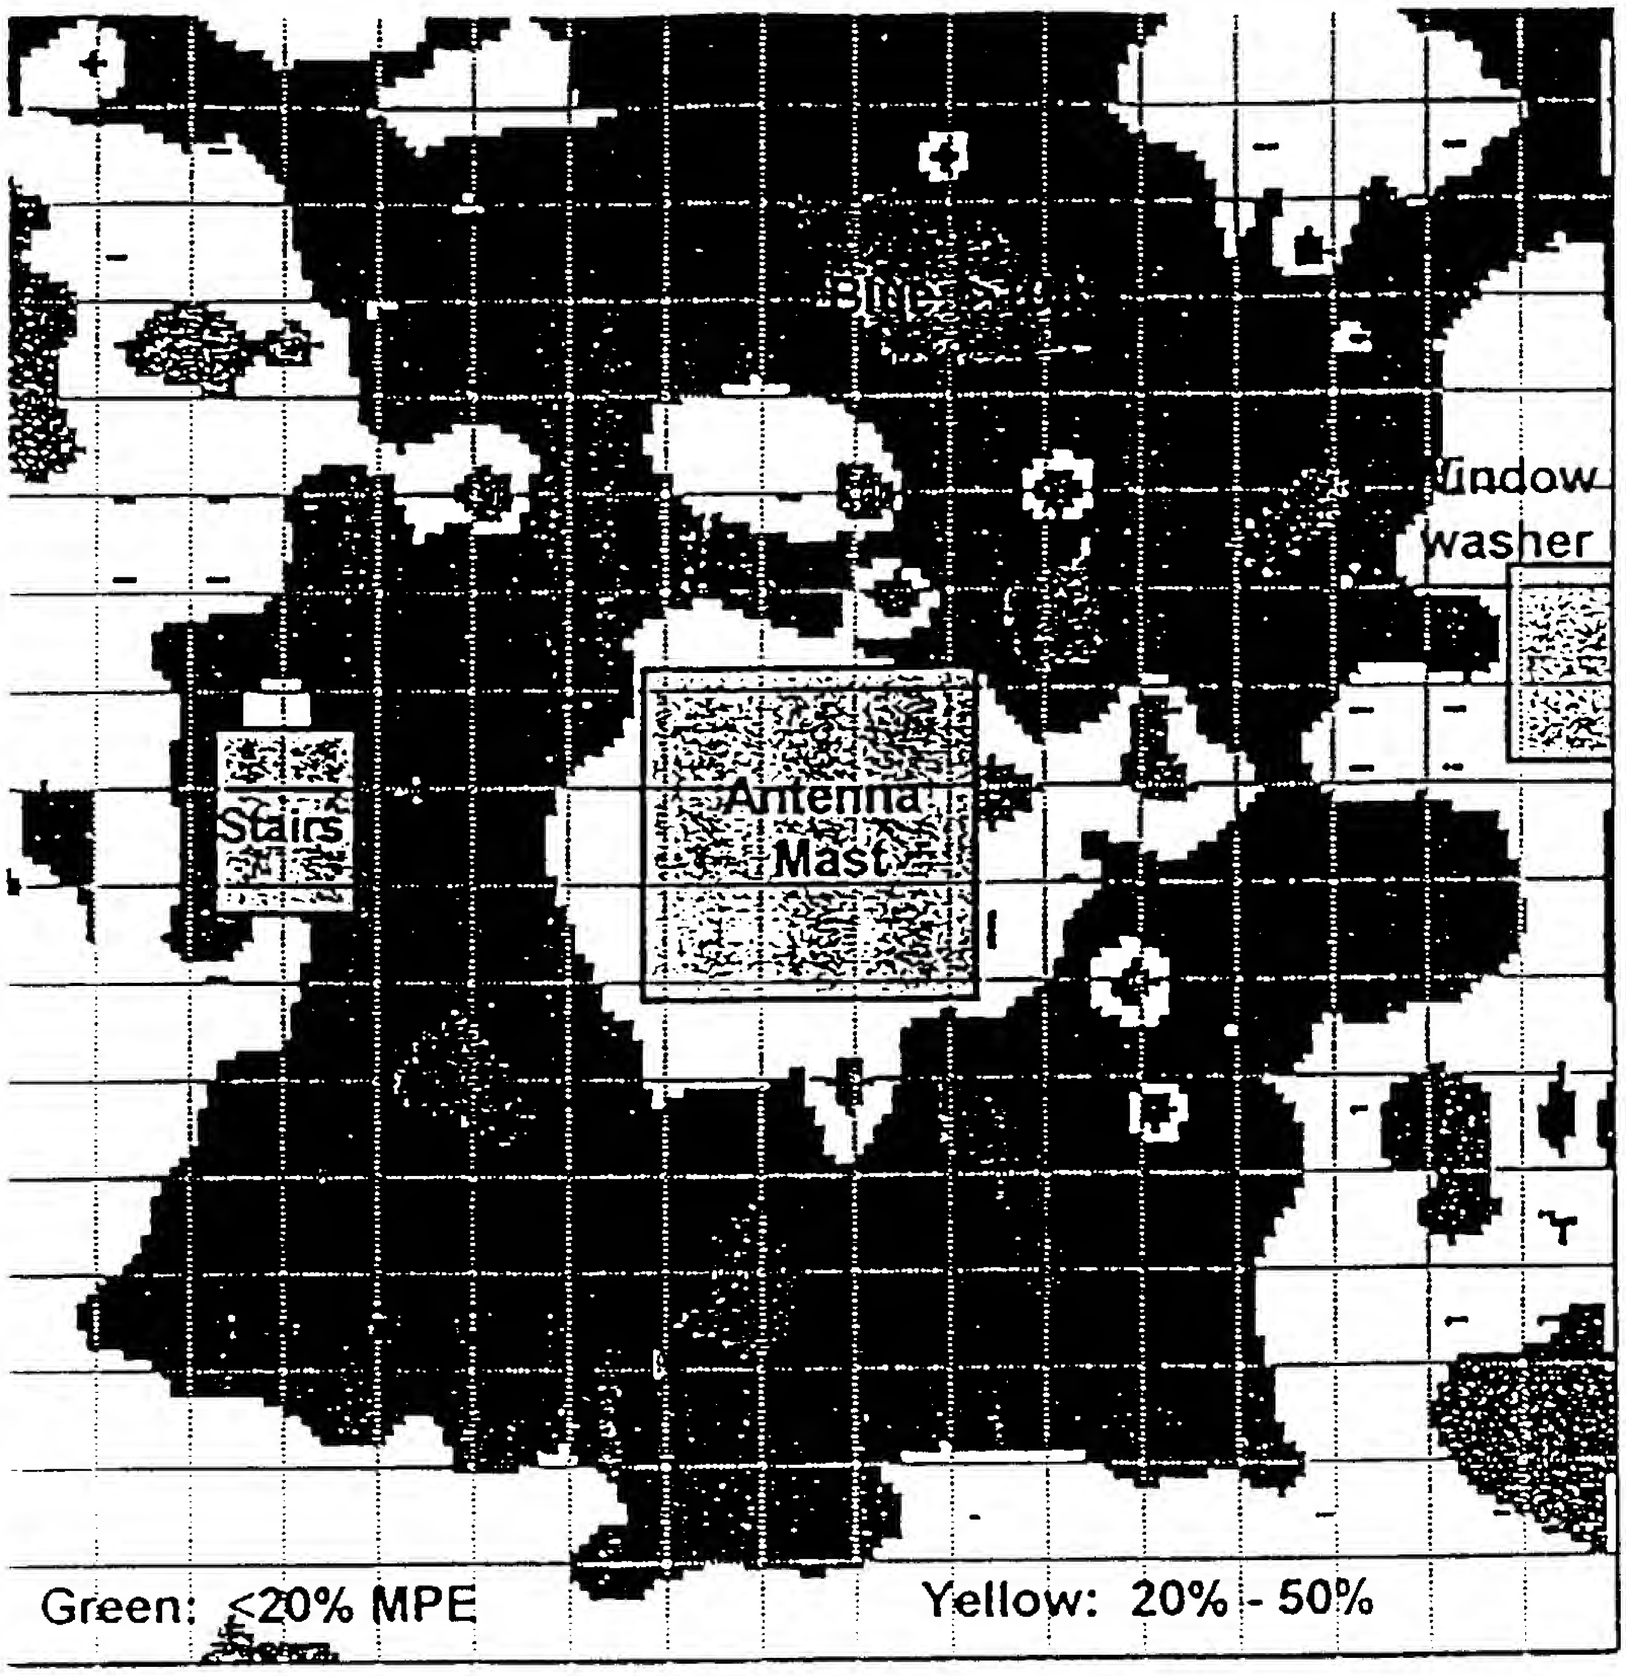
Figure 17. Roof map of emergency backup broadcast ambient RF fields with contribution of 72 MHz paging links removed via analysis with RoofView. Maximum field is 135.2% MPE

Statistical summary of RF Fields on WTC roof (see Figure 17)		
Percent occupational MPE range (%)	Roof area in this range (ft^2)	Percent of roof area in this range (%)
0-20	1135	4.17
21-50	11034	40.56
51-100	14148	52.01
>100	888	3.26

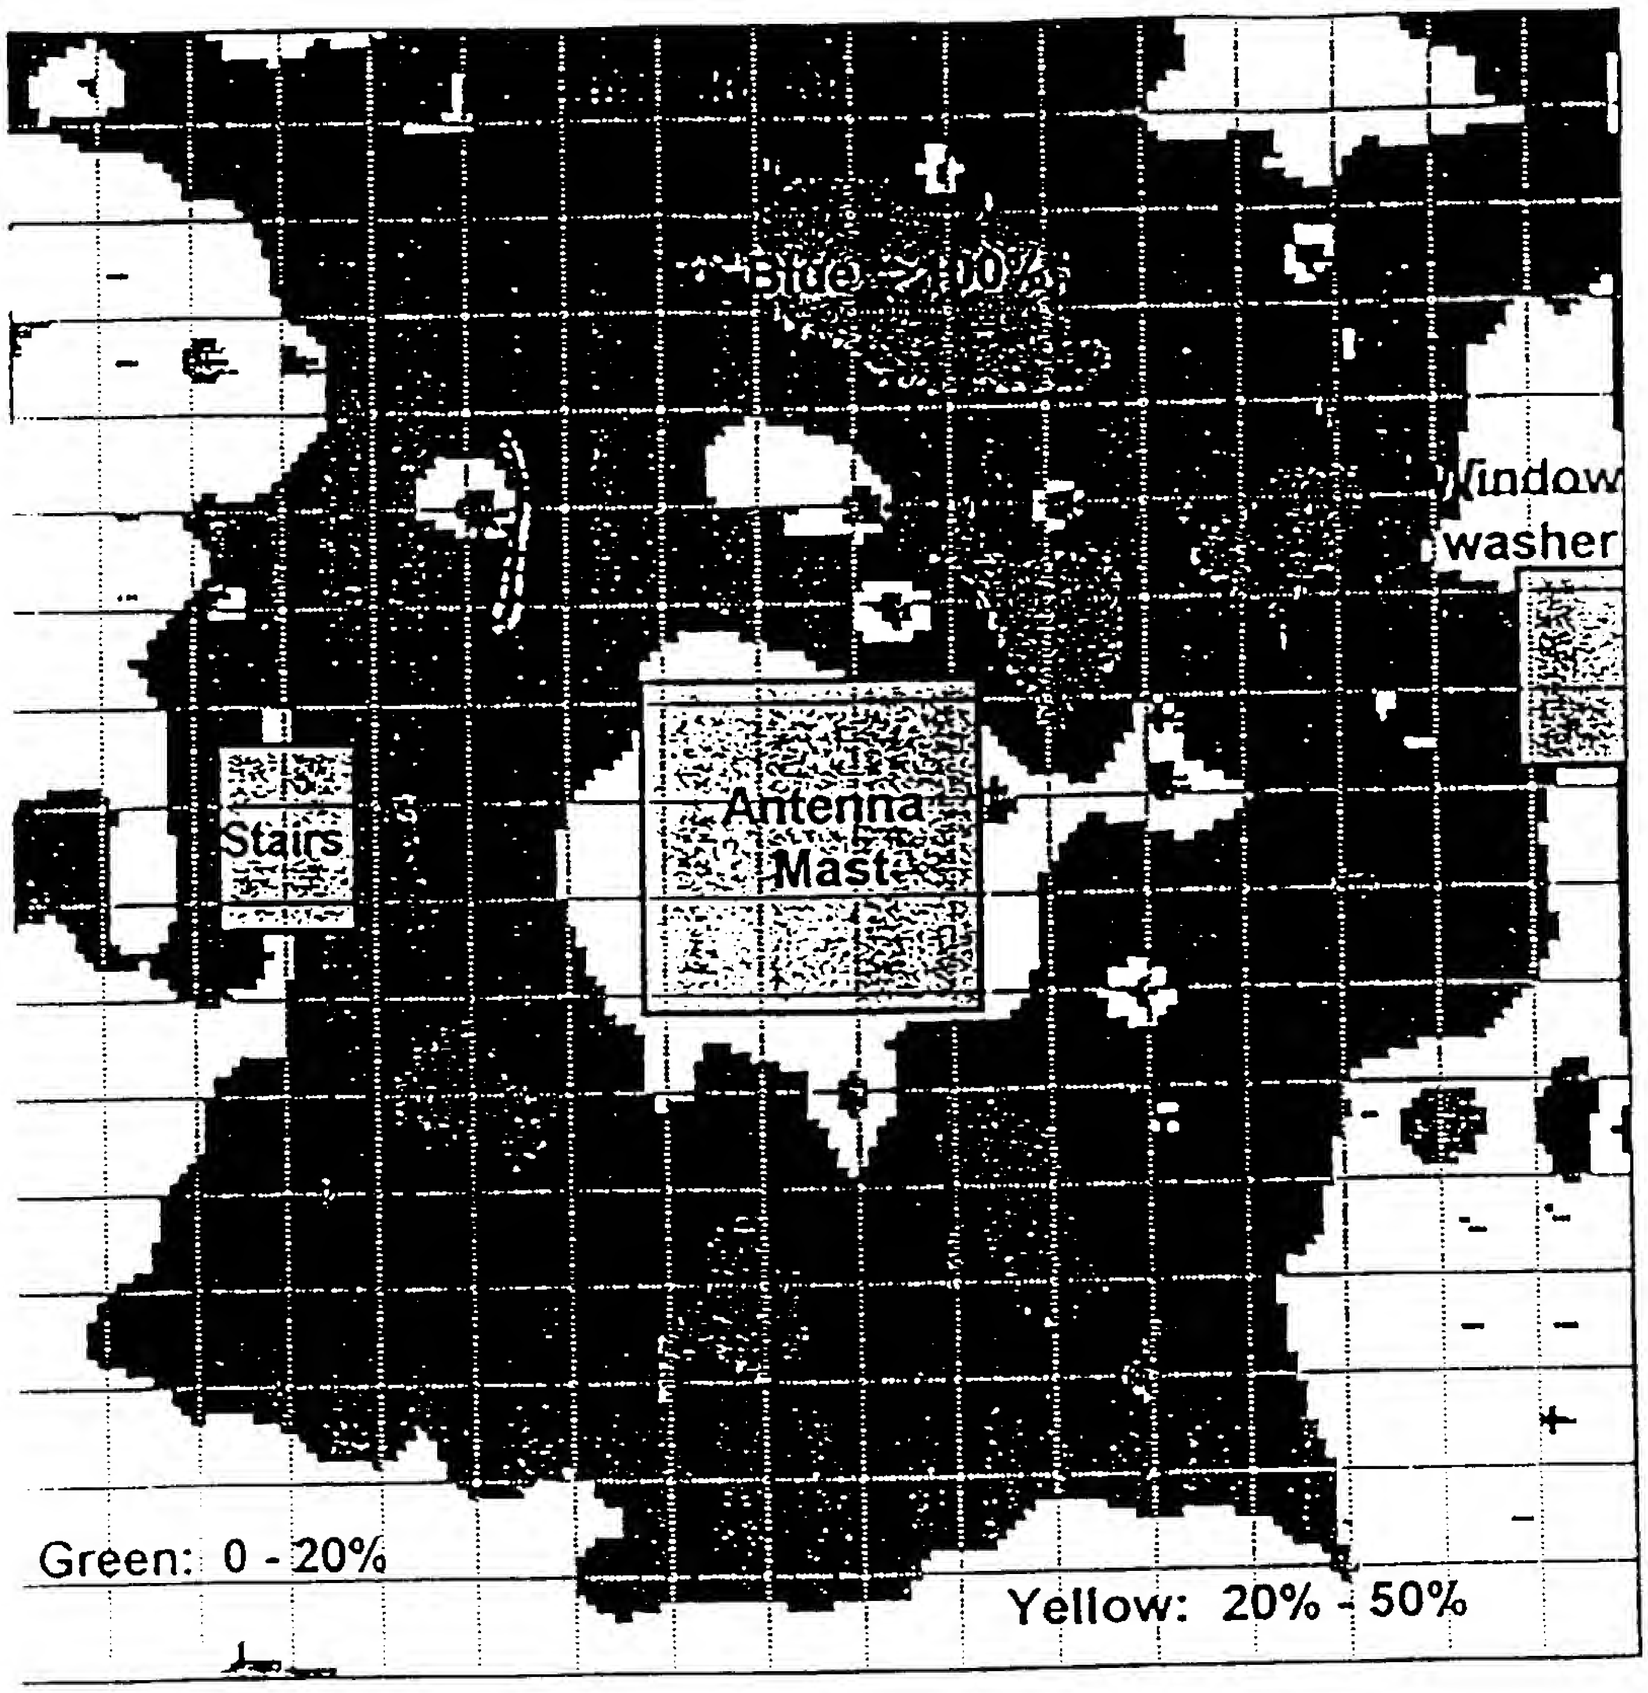
Figure 18. Roof map of RF fields during emergency broadcast backup operations with calculated effect of all wireless antennas raised at least 6 feet above roof level Maximum field is 149 3% MPE

Statistical summary of RF Fields on WTC roof (see Figure 18)		
Percent occupational MPE range (%)	Roof area in this range (ft^2)	Percent of roof area in this range (%)
0-20	249	0 92
21-50	9104	33 46
51-100	16151	59 37
>100	1701	6 25

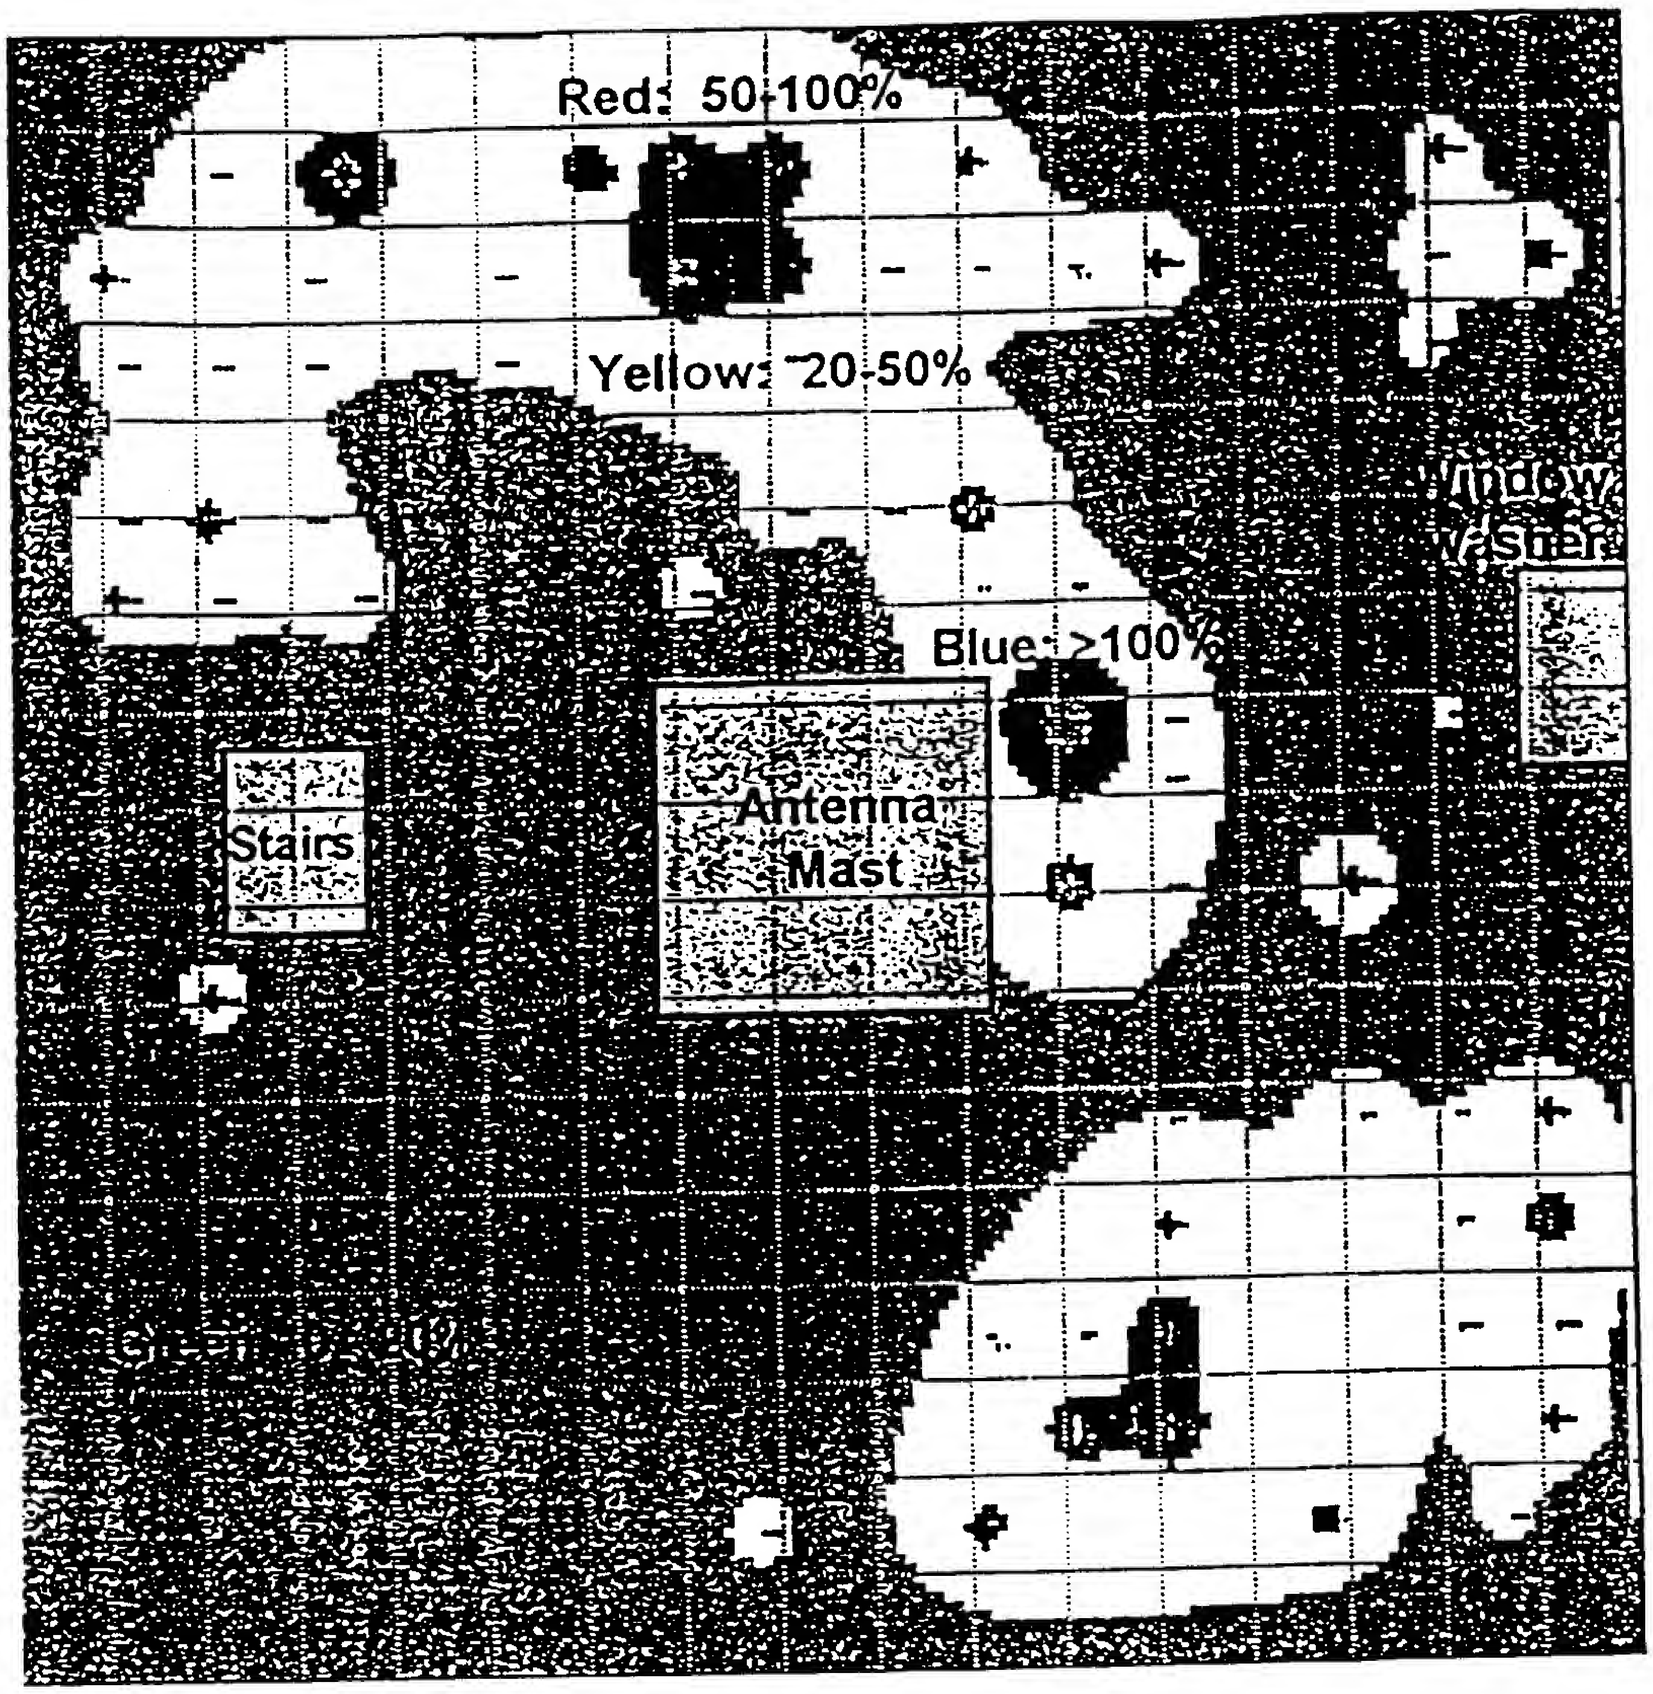
Figure 19. RoofView computed roof map for all wireless telecommunications antennas assumed operating but without contribution of RF fields from any of 72 MHz paging links or any contribution from broadcasting facilities. Maximum field is 273.9% MPE

Statistical summary of RF Fields on WTC roof (see Figure 19)		
Percent occupational MPE range (%)	Roof area in this range (ft^2)	Percent of roof area in this range (%)
0-20	17324	63.68
21-50	8960	32.94
51-100	833	3.06
>100	88	0.32

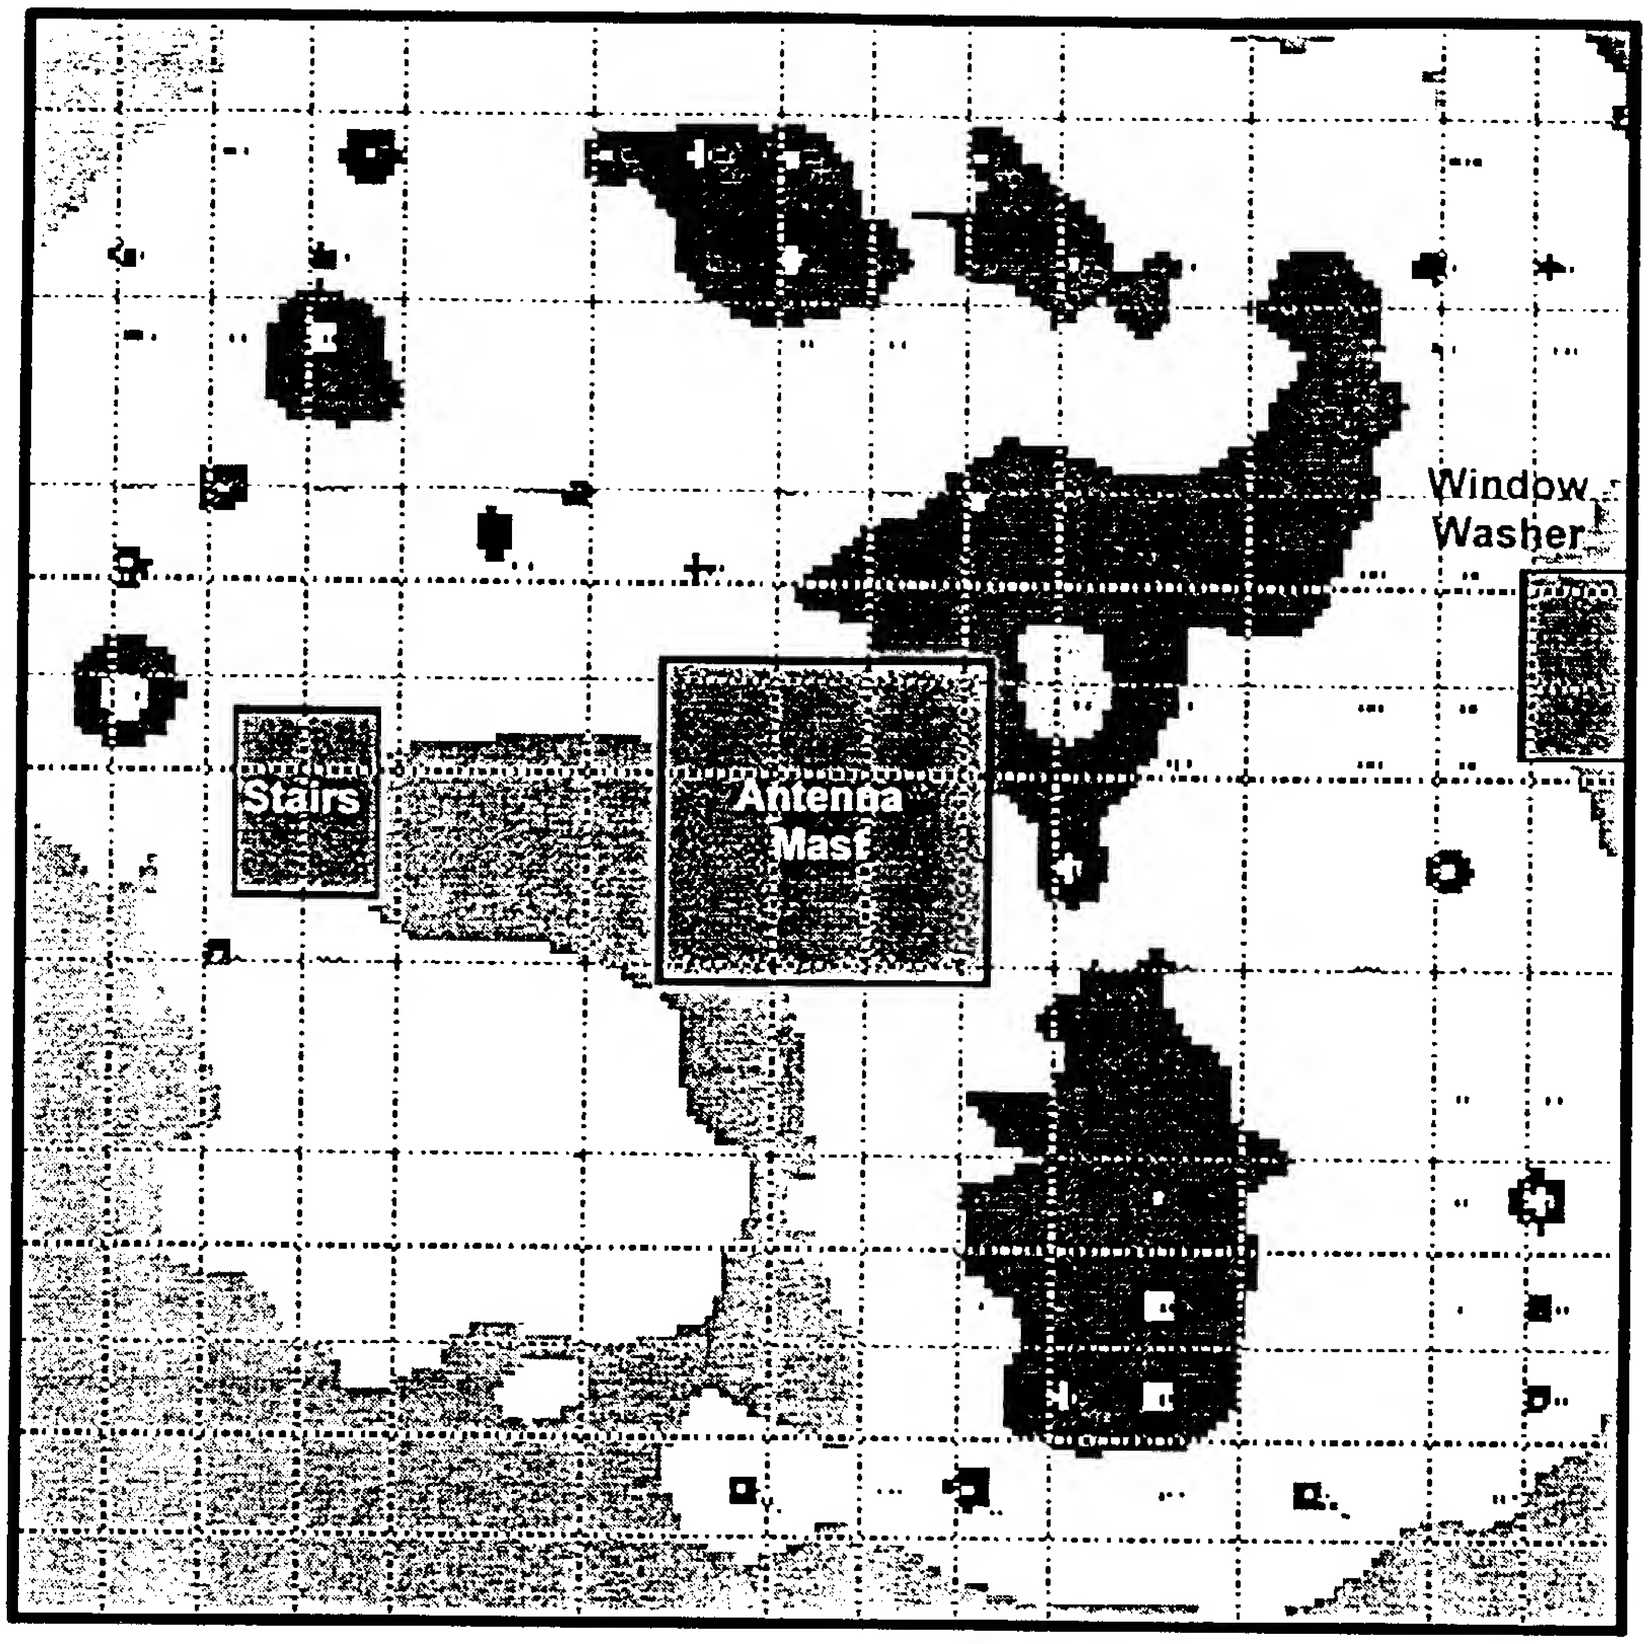
Figure 1. 1999 reevaluation of RF fields from measured ambient fields of normal broadcasting operations with calculated contribution of all wireless telecommunications antennas. Maximum field is 299.6% MPE.

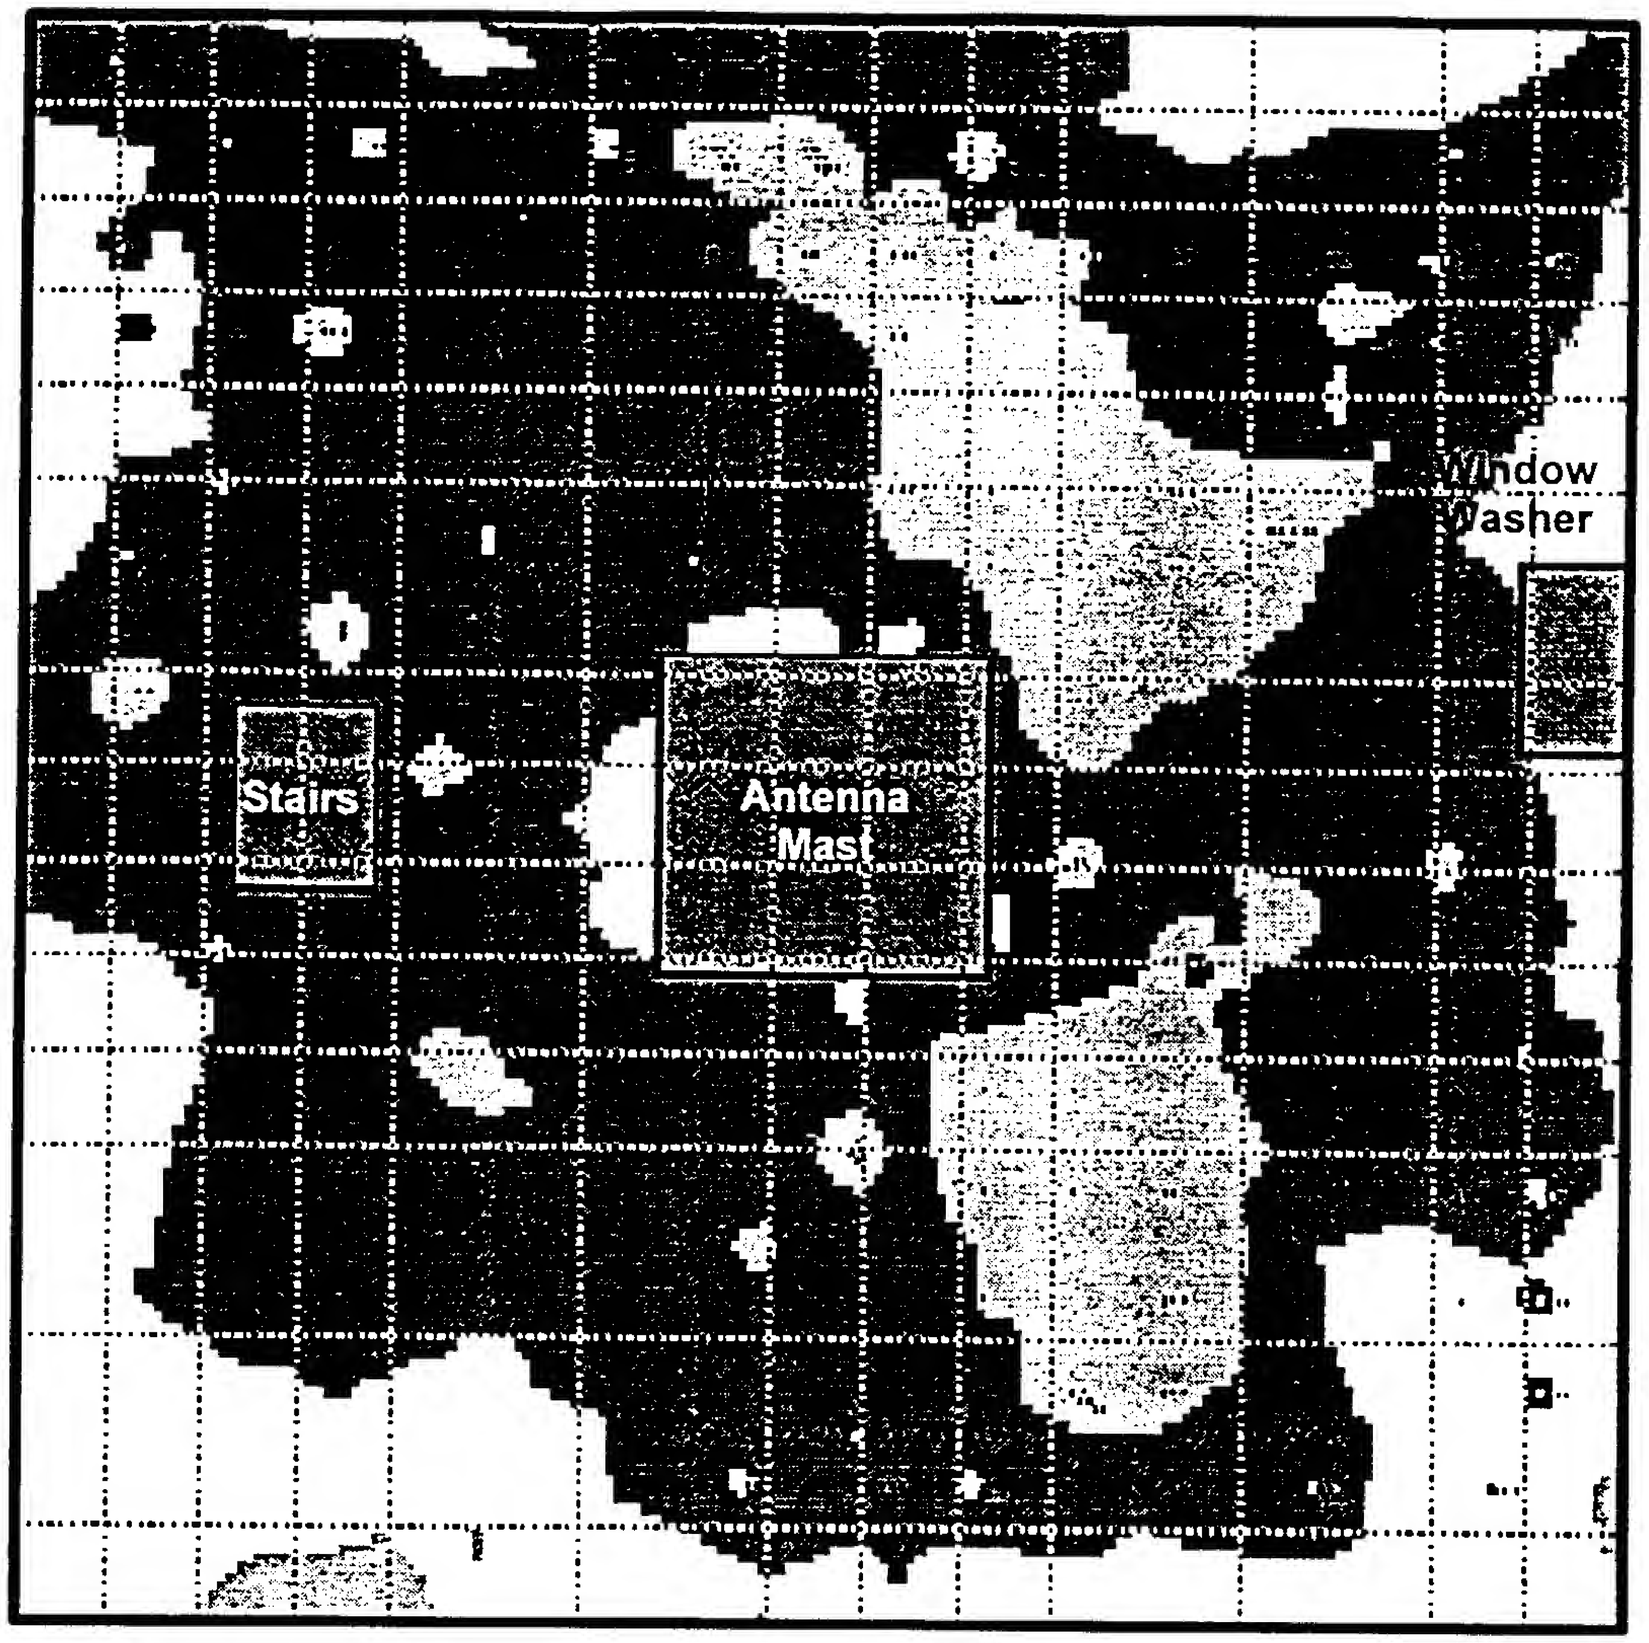
Figure 3. 1999 reanalysis of RF fields from measured ambient fields of tower maintenance broadcasting operations with calculated contribution of all wireless telecommunications antennas. Maximum field is 333.5% MPE.

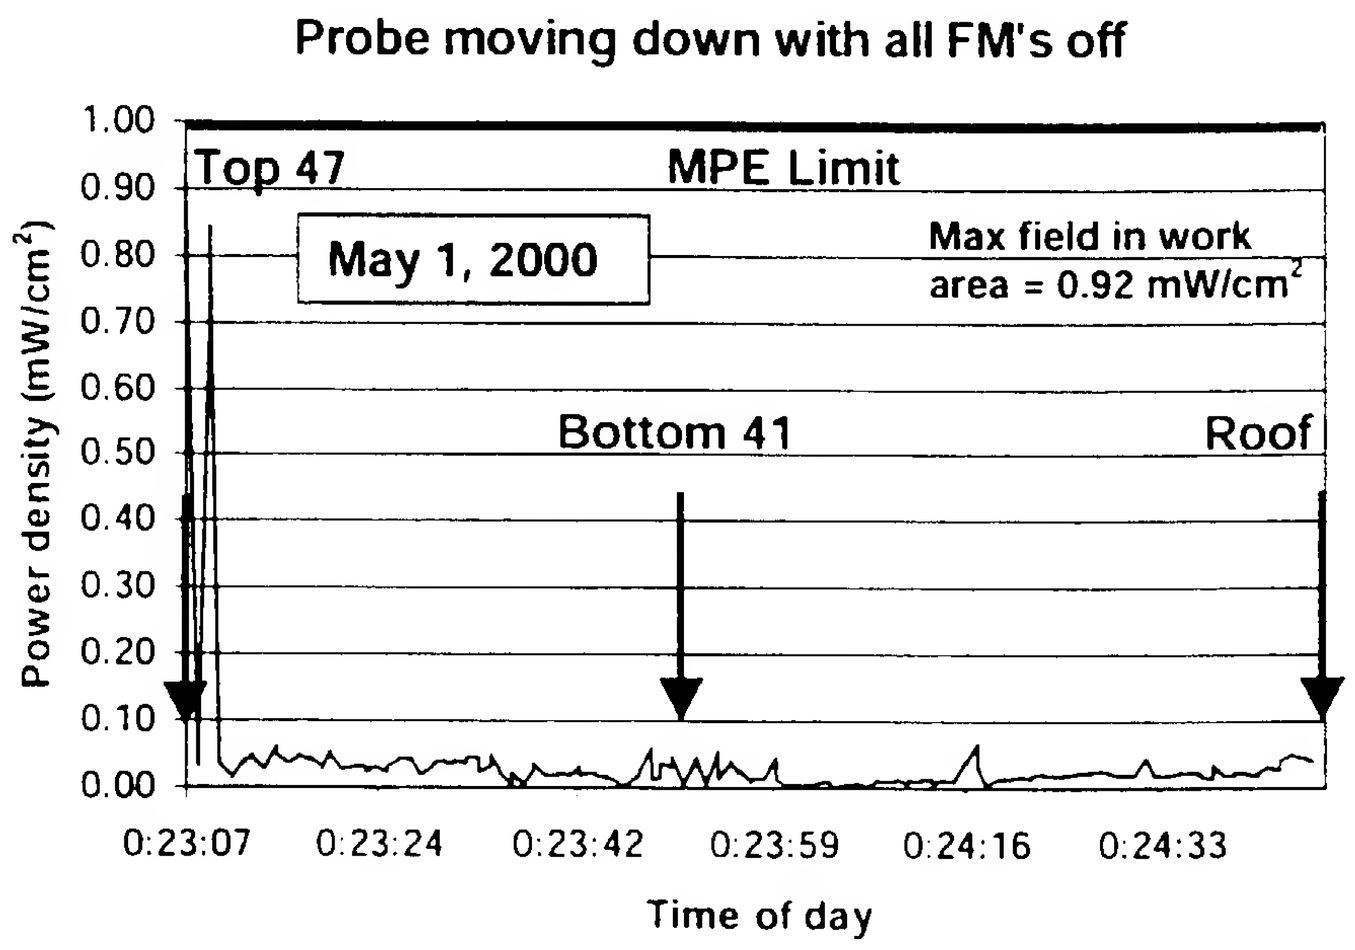
working area with the FM stations off. During the measurements, it was noted, as shown in Figure 22, that near the top of the channel 47 aperture, a narrow spike in the power density profile was observed. It is not apparent why this was observed but, in any event, the magnitude of the spike was less than 1 mW/cm^2, the MPE limit in the FM broadcast band. The most likely source of this narrow peak in field would be the channel 31 antenna that operates at 2,820 kW of ERP at 572 MHz where the MPE limit is 1.9 mW/cm^2. Thus, this value, while not clear what the source was, is less than the MPE for either the FM band or the UHF spectrum.

Figure 22. Plane wave equivalent power density measured parallel to antenna mast on May 1, 2000, with normal broadcast operations but with all FM stations off and probe moving up.

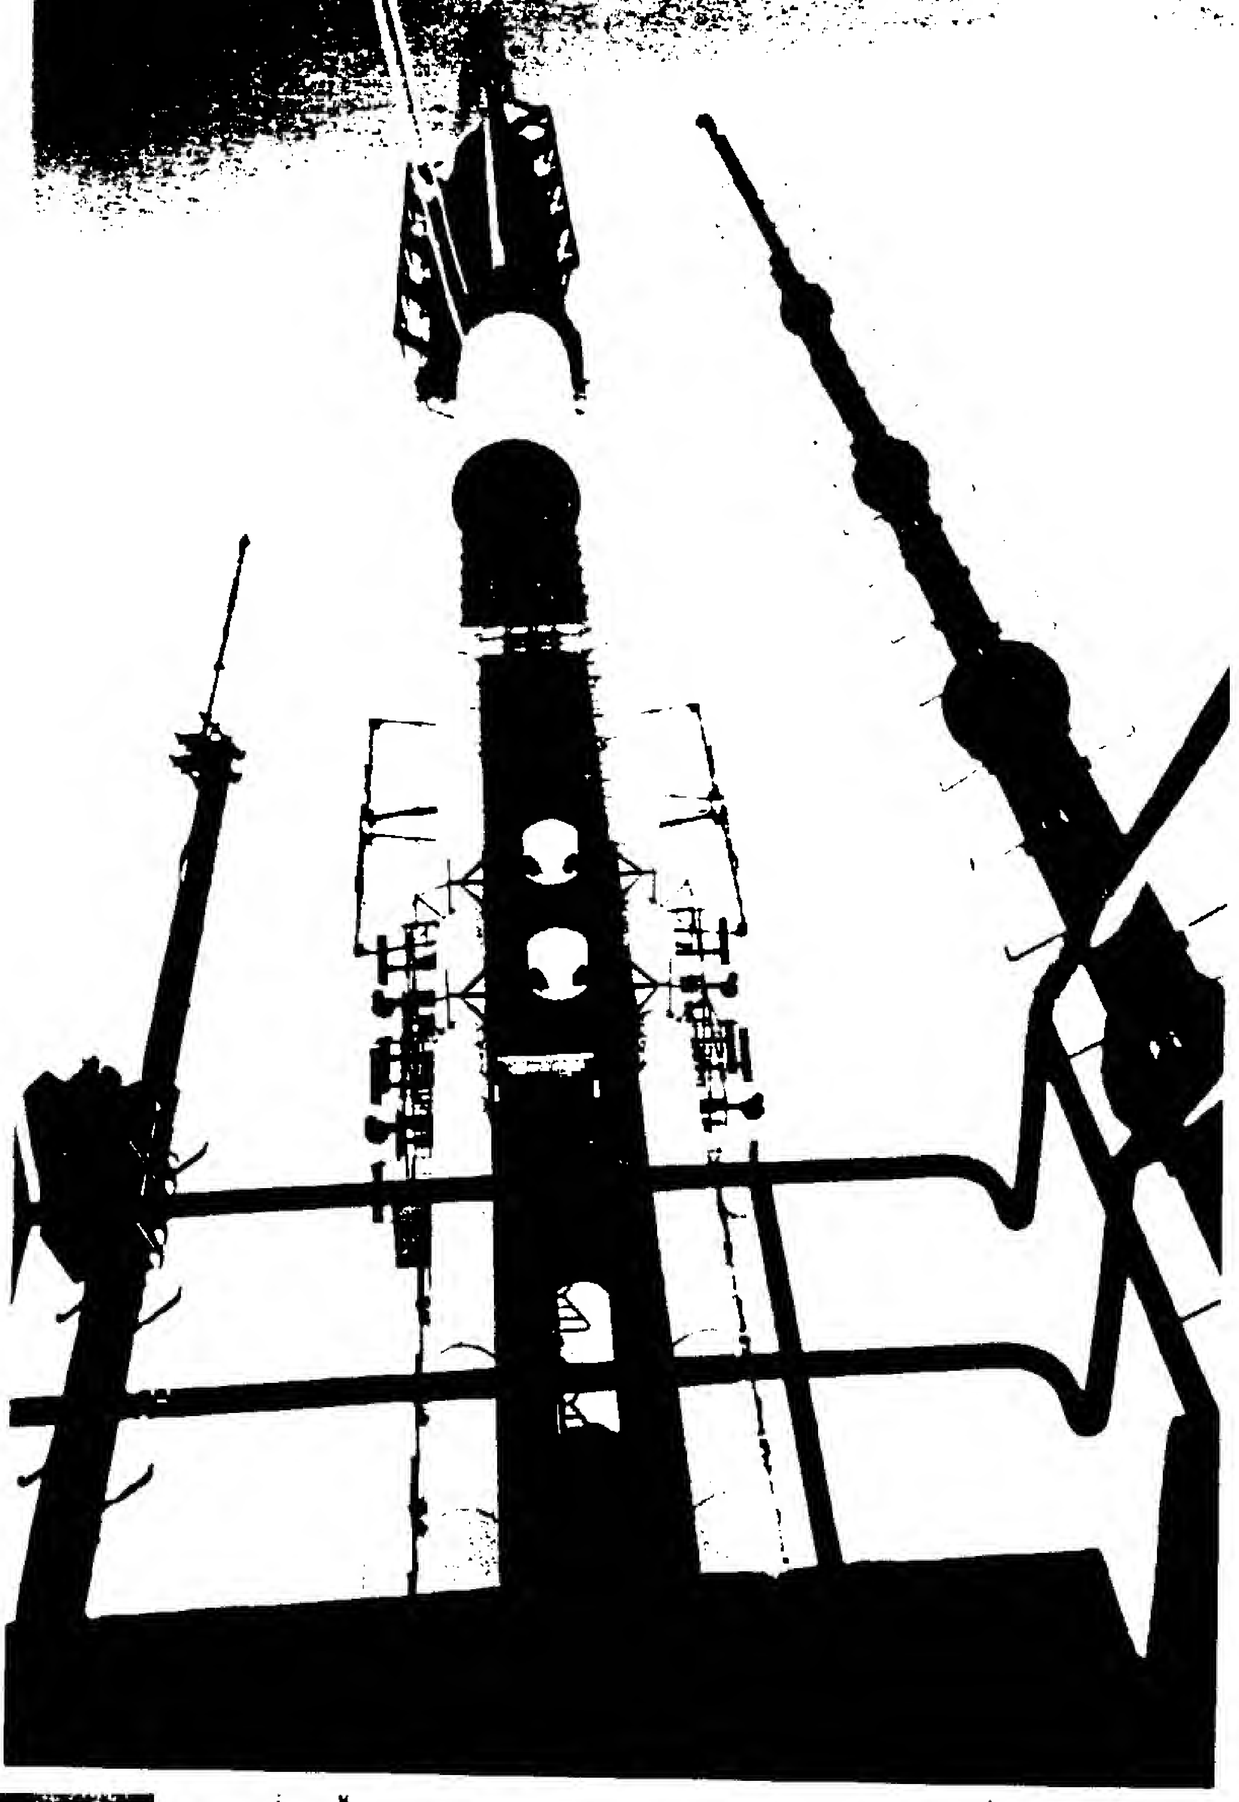
Photo #1:
360-Foot antenna mast on One World Trade Center.

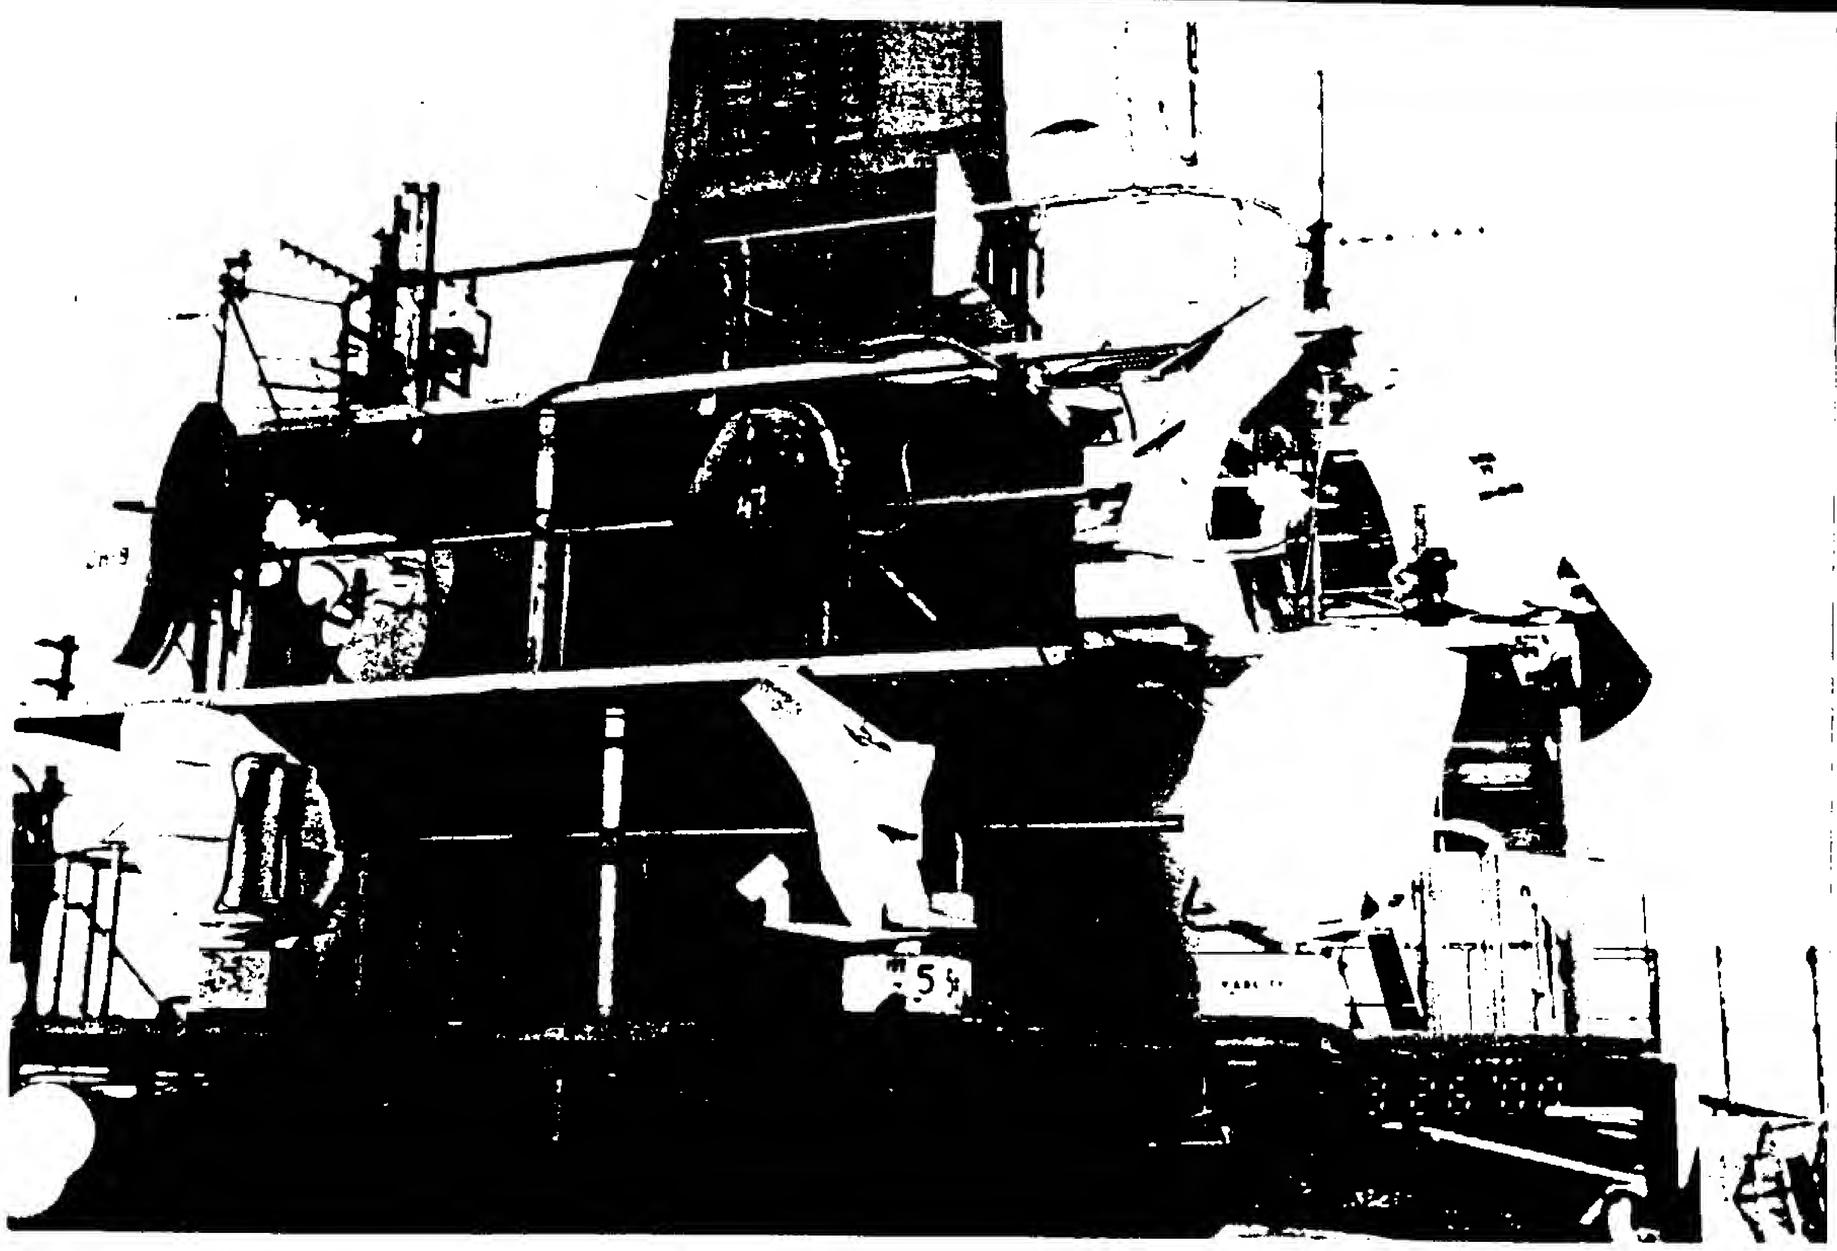
Photo #2: Base of antenna mast on One World Trade Center.
